AFWAL-TR-79-3095
VOLUME I

ADVANCED RESIDUAL STRENGTH DEGRADATION RATE
MODELING FOR ADVANCED COMPOSITE STRUCTURES
VOLUME I - TASK I: PRELIMINARY SCREENING

Lockheed-California Company
Burbank, California

August 1979
Final Report for 1 August 1977 to 29 June 1979

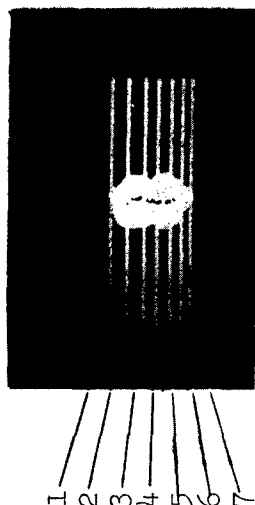
Figure 20

C-SCAN RESULTS

B-SCAN RESULTS

Figure 20. Damage Growth Results for 24 ply Specimen KC-29 Containing a Damaged Hole. Maximum Stress = 21 ksi (145 MPa), $R = -1$

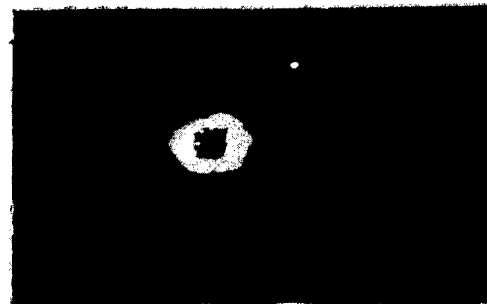
No significant damage in holes #37, 39, and 41.

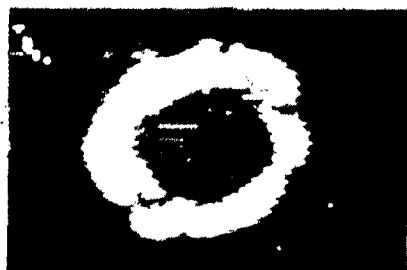
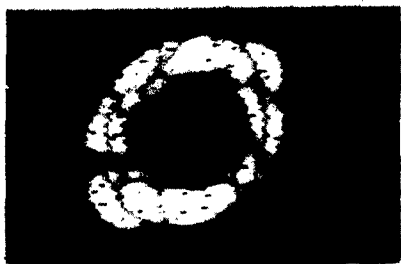
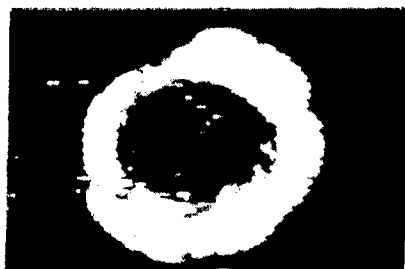
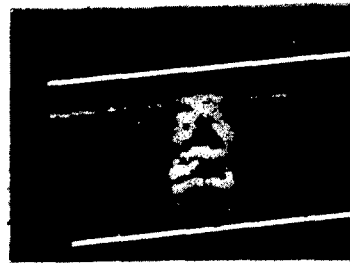
Cumulative
B-Scan

Figure 23. Variability of Hole Damage for Drilling Method
No. 1 in 32-Ply Laminate

The results of hole damage characterization are shown in Figures 23-25 for the 32 ply material and Figures 26-28 for the 24 ply material. The results show the damage to again be primarily located in the region of the internal ply levels, similar to that shown for the impact damage condition. All three drilling methods seem to indicate similar damage extents and locations for each of the two laminates. Method 5, however, showed somewhat inconsistent results in the 32 ply material as shown in Figure 25. As a result, drilling method number 3 using a standard 3/8 inch (9.5 mm) high speed drill was selected for use in the balance of the program.

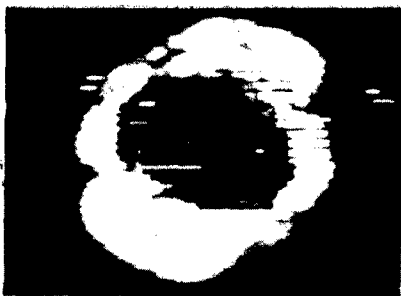
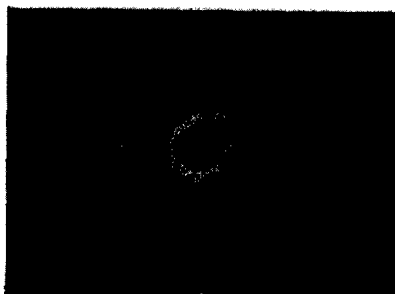
Cumulative
B-Scan

Figure 24. Variability of Hole Damage for Drilling Method No. 3 for 32-Ply Laminate.

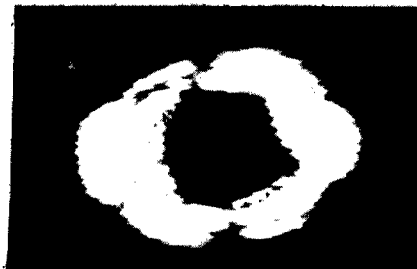
Figure 26. Variability of Hole Damage for Drilling Method No. 1 for 24-Ply Laminate

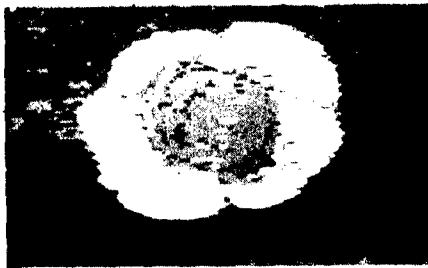
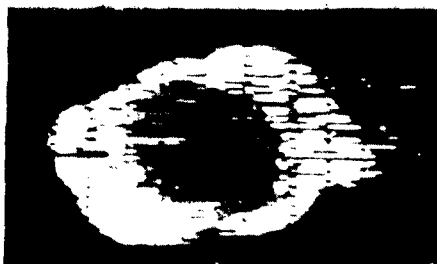
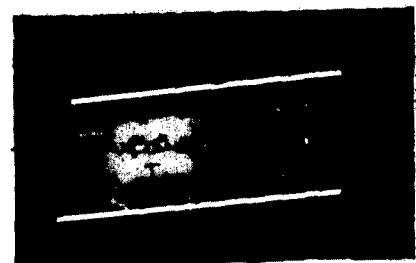
Figure 27. Variability of Hole Damage for Drilling Method
No. 3 for 24-Ply Laminate

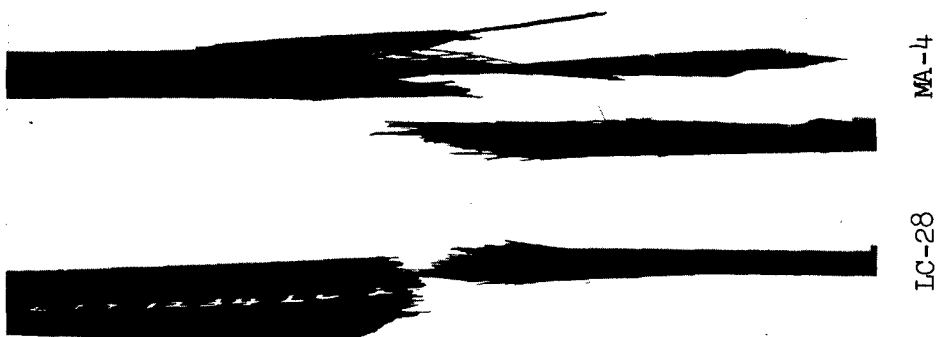
MA-4

LC-28

730 MPa

862 MPa

Figure 37. Type 3 Failure Modes observed in Low Strength Tension Failures of Impact Damaged 24 Ply 67% 0° Fiber Laminates

Occurrence of the remaining (Type 3) failure mode was, however, typical only of the two lowest failure stress values. The Type 3 failure mode, shown in Figure 37, was observed only in specimen MA-4 and LC-28. Both of these failures exhibited extensive delamination, a characteristic not observed in either the Type 1 or Type 2 failures. While specimen MA-4 had anomalous loading history in the form of a previous load cycle to $> 80\%$ of the subsequent fracture load, no similar anomalous load history was found for LC-28. Note however, that LC-28 exhibited the lowest modulus value of the nine test specimens, a drop in modulus being the major difference observed between the first and second loading of specimen MA-4. However, since no significant anomaly in the history of LC-28 can be identified, the data point is not eliminated at this point in time. The effect of this data point on the statistical distribution is discussed in the subsequent section.

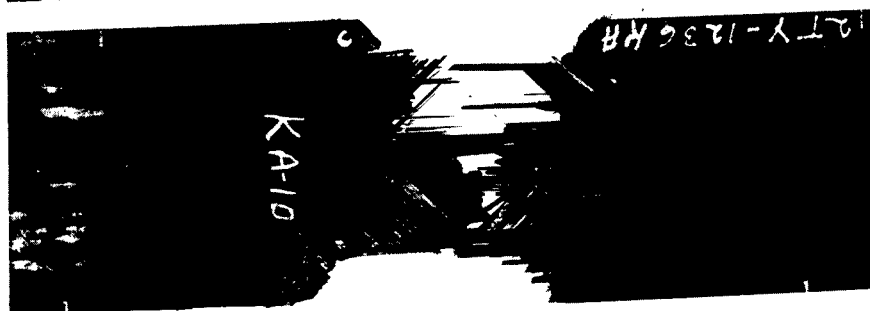
LC-22
18,443 Cycles

KA-10
1290 Cycles

a) Front Surface

Figure 59. Fracture Appearance of Impact Damaged 24-Ply 67% 0° Fiber Laminates Fatigue Tested at ± 36.8 ksi (254 MPa)

Typical failures at the various stress levels are shown in Figures 58 and 59 for the damaged hole and impact damaged specimens, respectively.

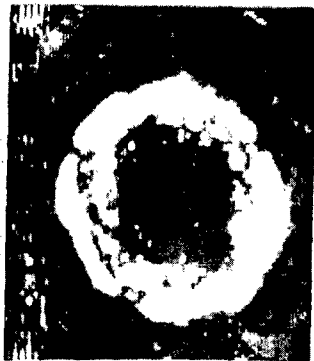
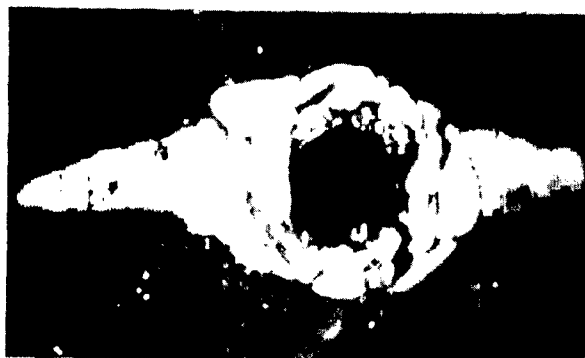
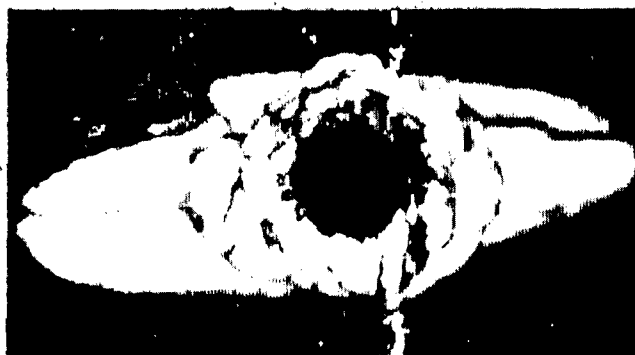
→ 0° Fiber
TV C-Scan, 1 X

Figure 9la. Damage Growth Characteristics of Damaged Hole Specimen DA-5, 32-Ply Quasi-Isotropic Laminate, $R = -1$, $\sigma_{\max} = 26 \text{ ksi (179 MPa)}$

Typical damage growth results are presented in Figures 91 through 93. Additional data for other stress levels are presented in Appendix C.

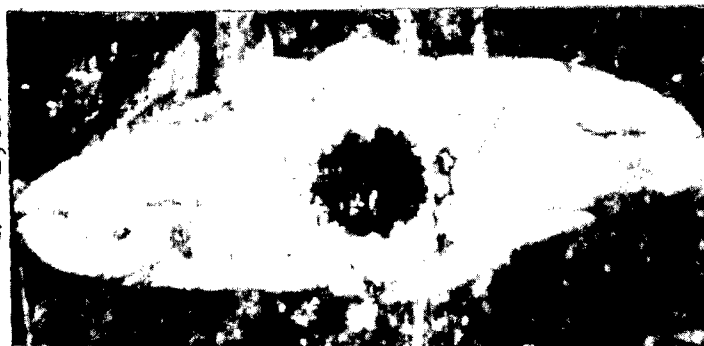
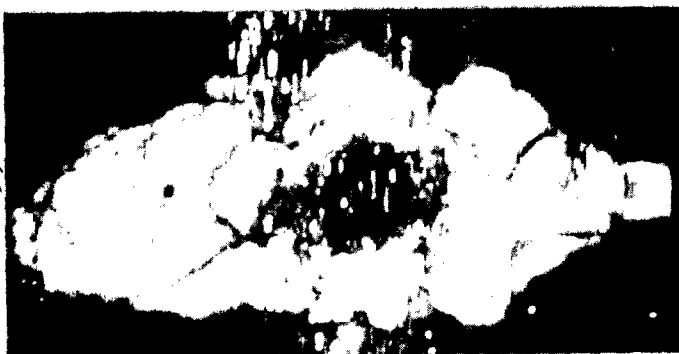
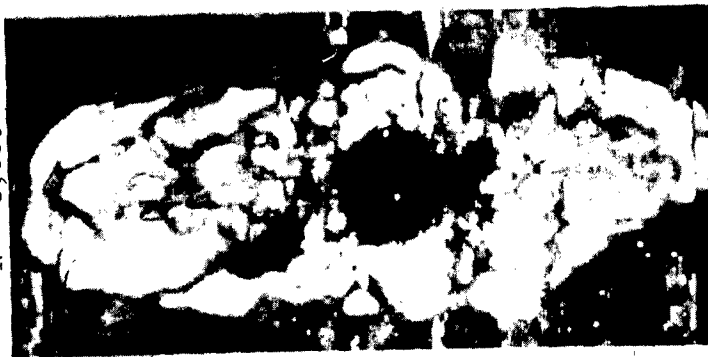
→ 0° Fiber
TV C-Scan, 1 X

Figure 9lb. Damage Growth Characteristics of Damaged Hole Specimen DA-5, 32-Ply Quasi-Isotropic Laminate, $R = -1$, $\sigma_{\max} = 26 \text{ ksi}$ (179 MPa)

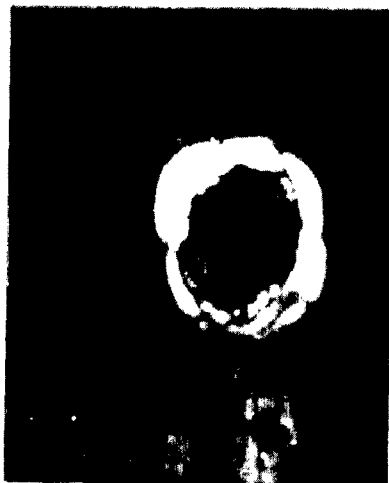
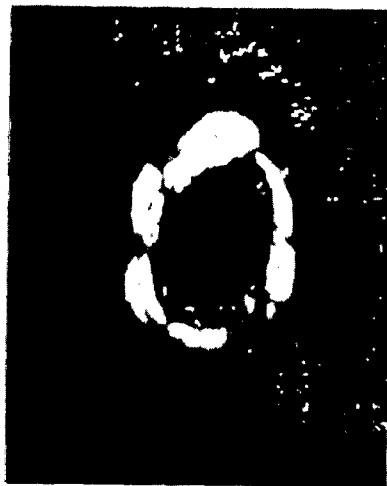
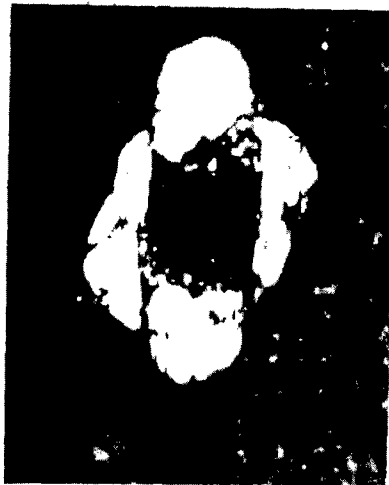
Figure 18A. Damage Growth Results for 24 ply Specimen MC-25 Containing a Damaged Hole. Maximum Stress = 26 ksi (179 MPa), $R = -1$
